**EMERGENCY OPERATION PLAN
MOODUS RESERVOIR DAM
EAST HADDAM, CONNECTICUT**

June 1998

**US Army Corps
of Engineers**

**MOODUS RESERVOIR DAM
EAST HADDAM, CONNECTICUT**

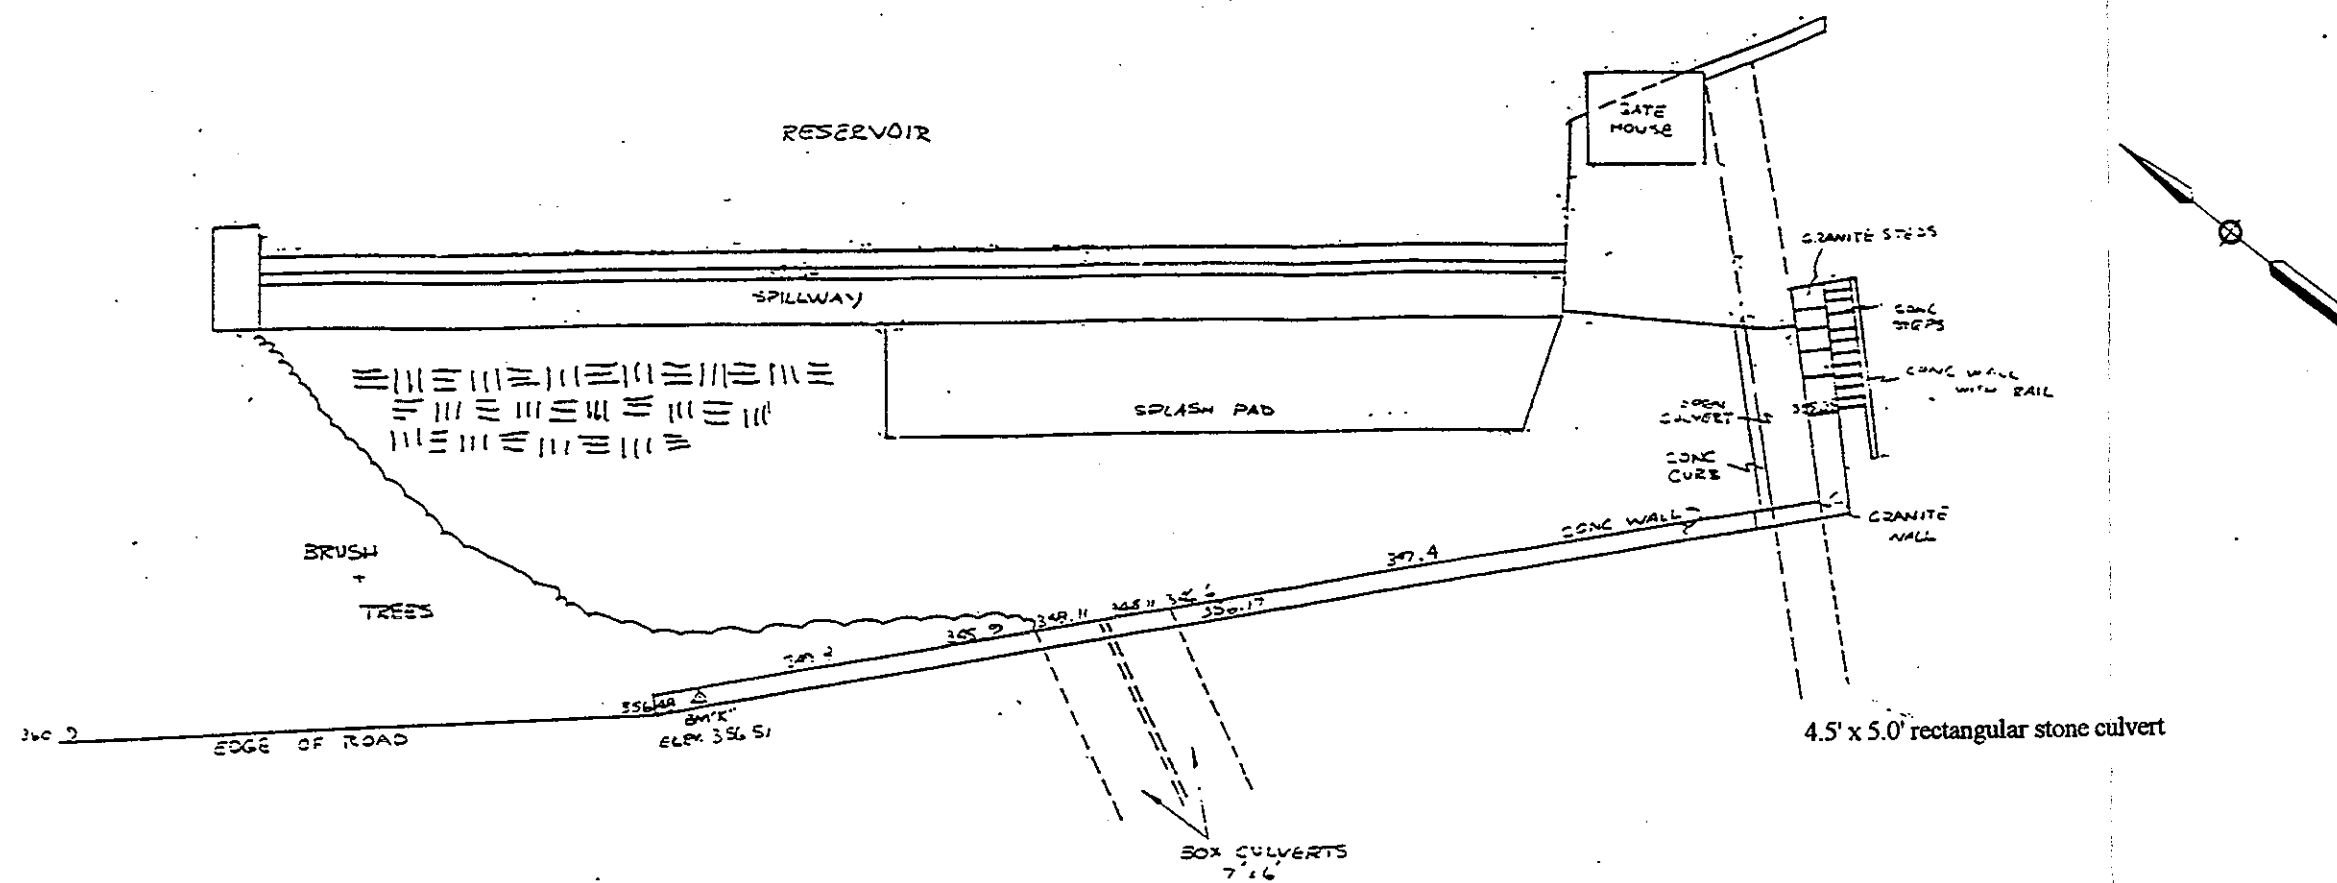
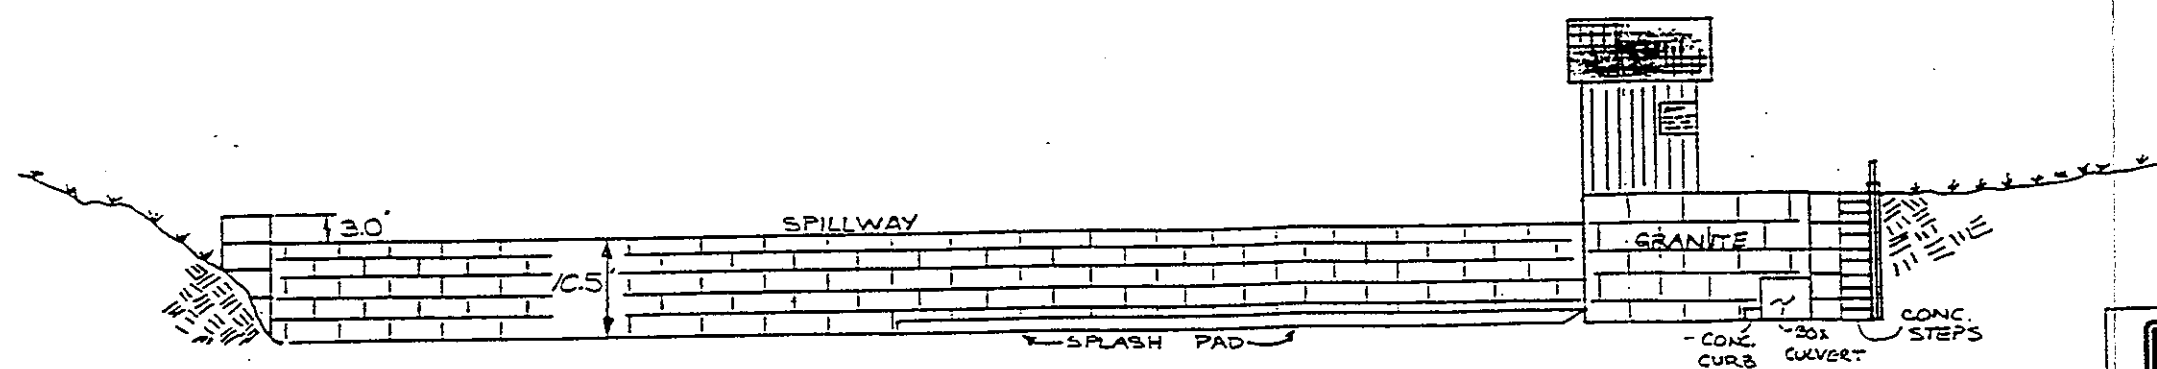
PLAN VIEW

ELEVATION VIEW

<u>Follows Page</u>
Plate 1	Study Area	13
Plate 2	Moodus Reservoir Dam - Plan and Profile	13
Plate 3	Inundation Mapping, Sheet 1 of 2	13
Plate 4	Inundation Mapping, Sheet 2 of 2	13
